**SYSTEMS GROUP CHAIRMAN FACTUAL REPORT ADDENDUM FOR
BOEING/AIR FORCE CENTER WING TANK FUEL HEATING STUDY**

A. ACCIDENT: DCA96MA070

Airplane : Boeing 747- 131, N93119
Operated as Trans World Airlines (TWA) Flight 800

TITLE CENTER WING TANK FUEL HEATING STUDY
(VOLUME I OF IV)

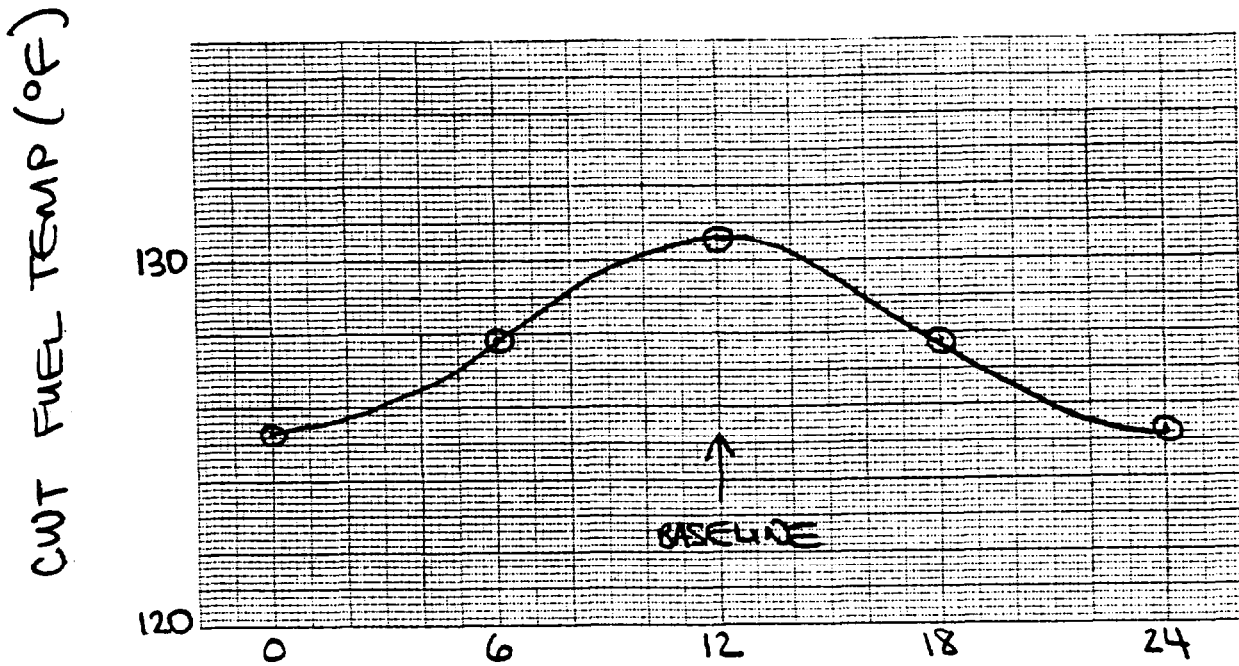
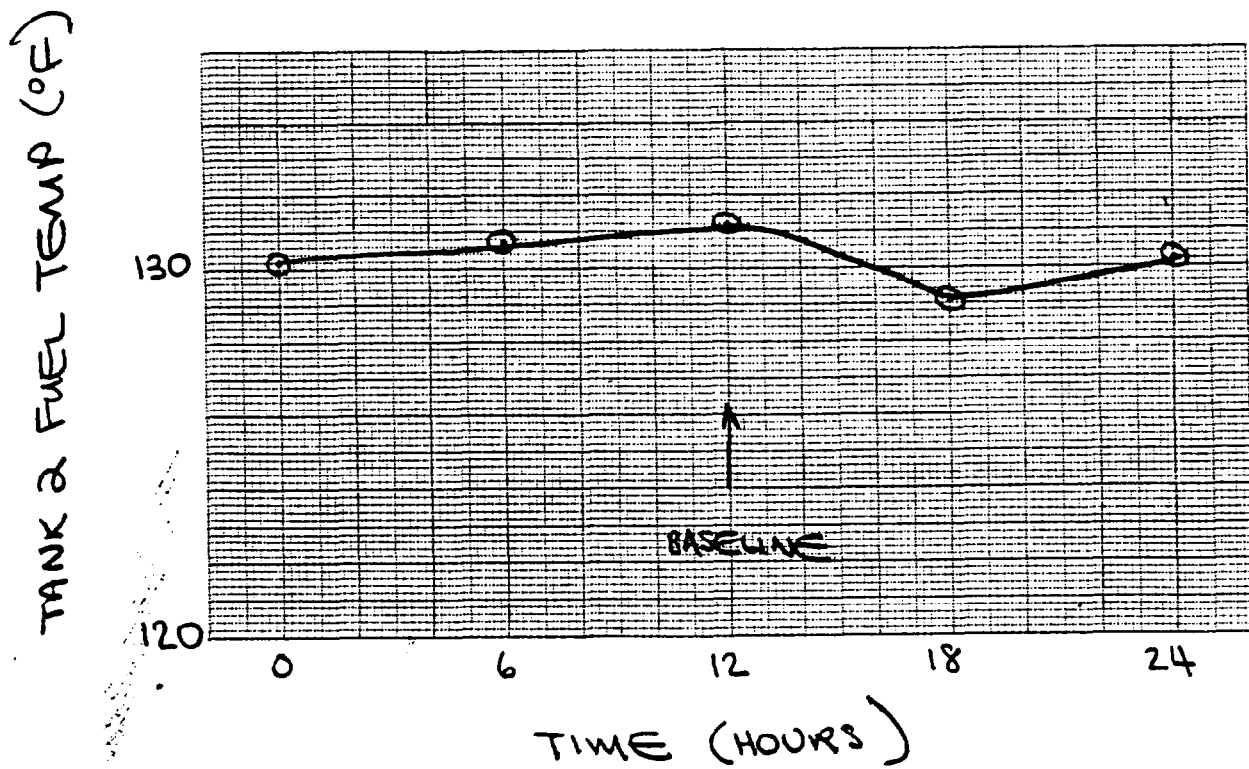
FIGURE 2.17

FUEL TEMPERATURE VARIATION WITH RELATIVE LANDING TIME

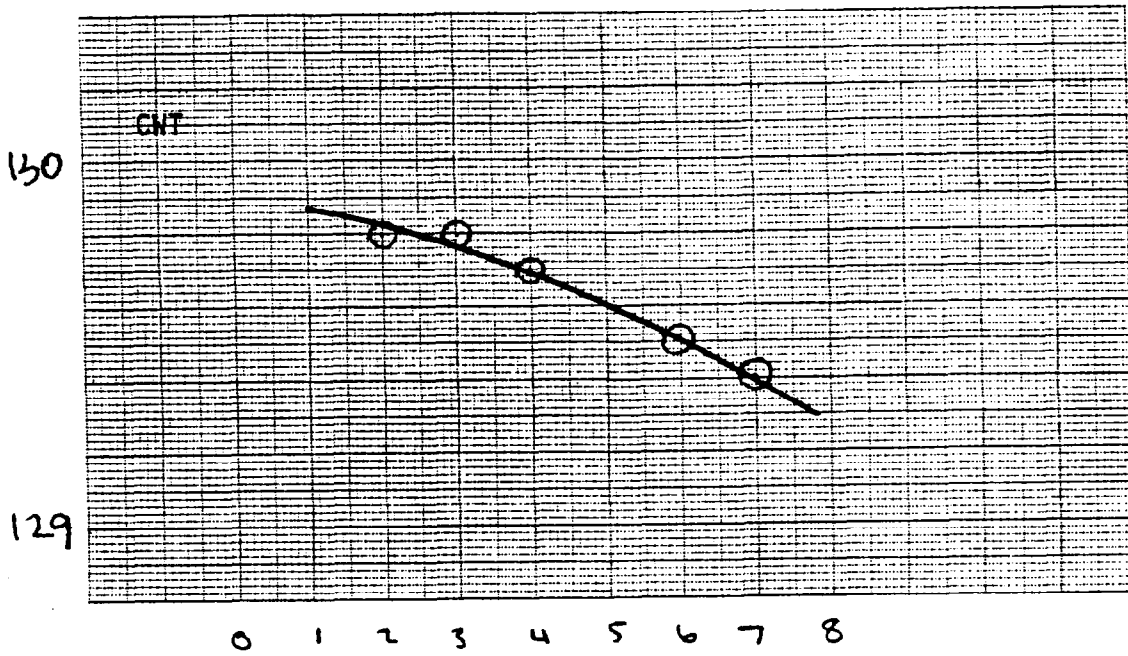
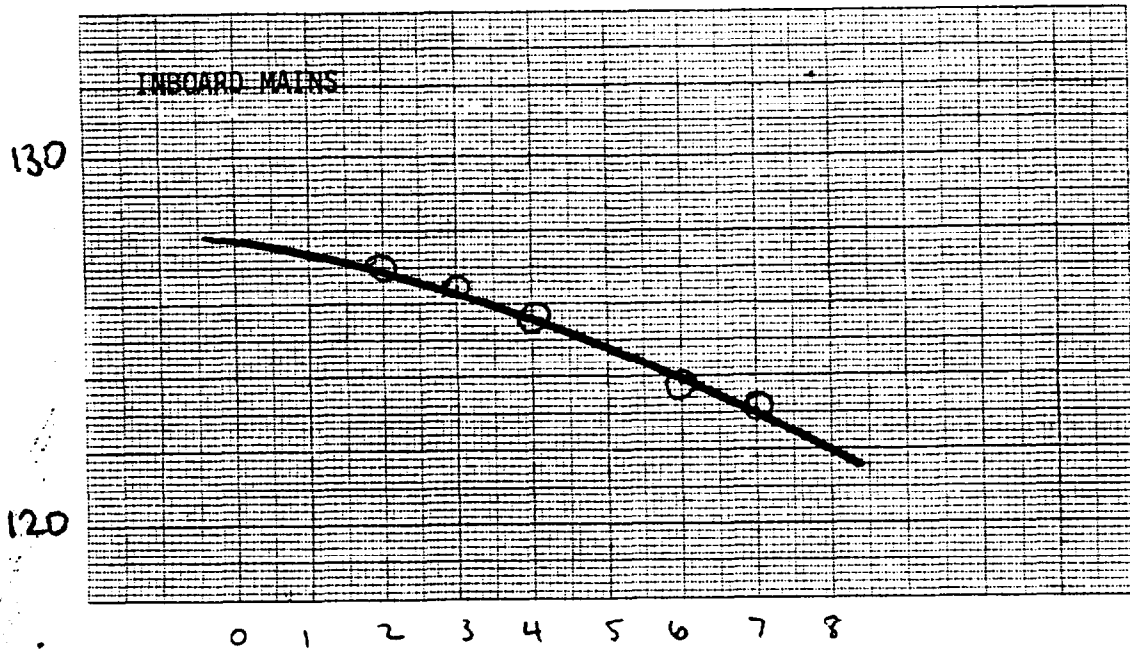
FIGURE 2.18

Figure 2.18 shows the impact of varying the time lag between sunrise and ambient air temperature increase. Due to an oversight the models used in this study had lag times ranging from the intended 2 hours to 7 hours. From the Figure it can be seen that this would cause errors on the order of:

FUEL TEMPERATURE VARIATION WITH SOLAR LOAD/AIR TEMPERATURE LAG TIME

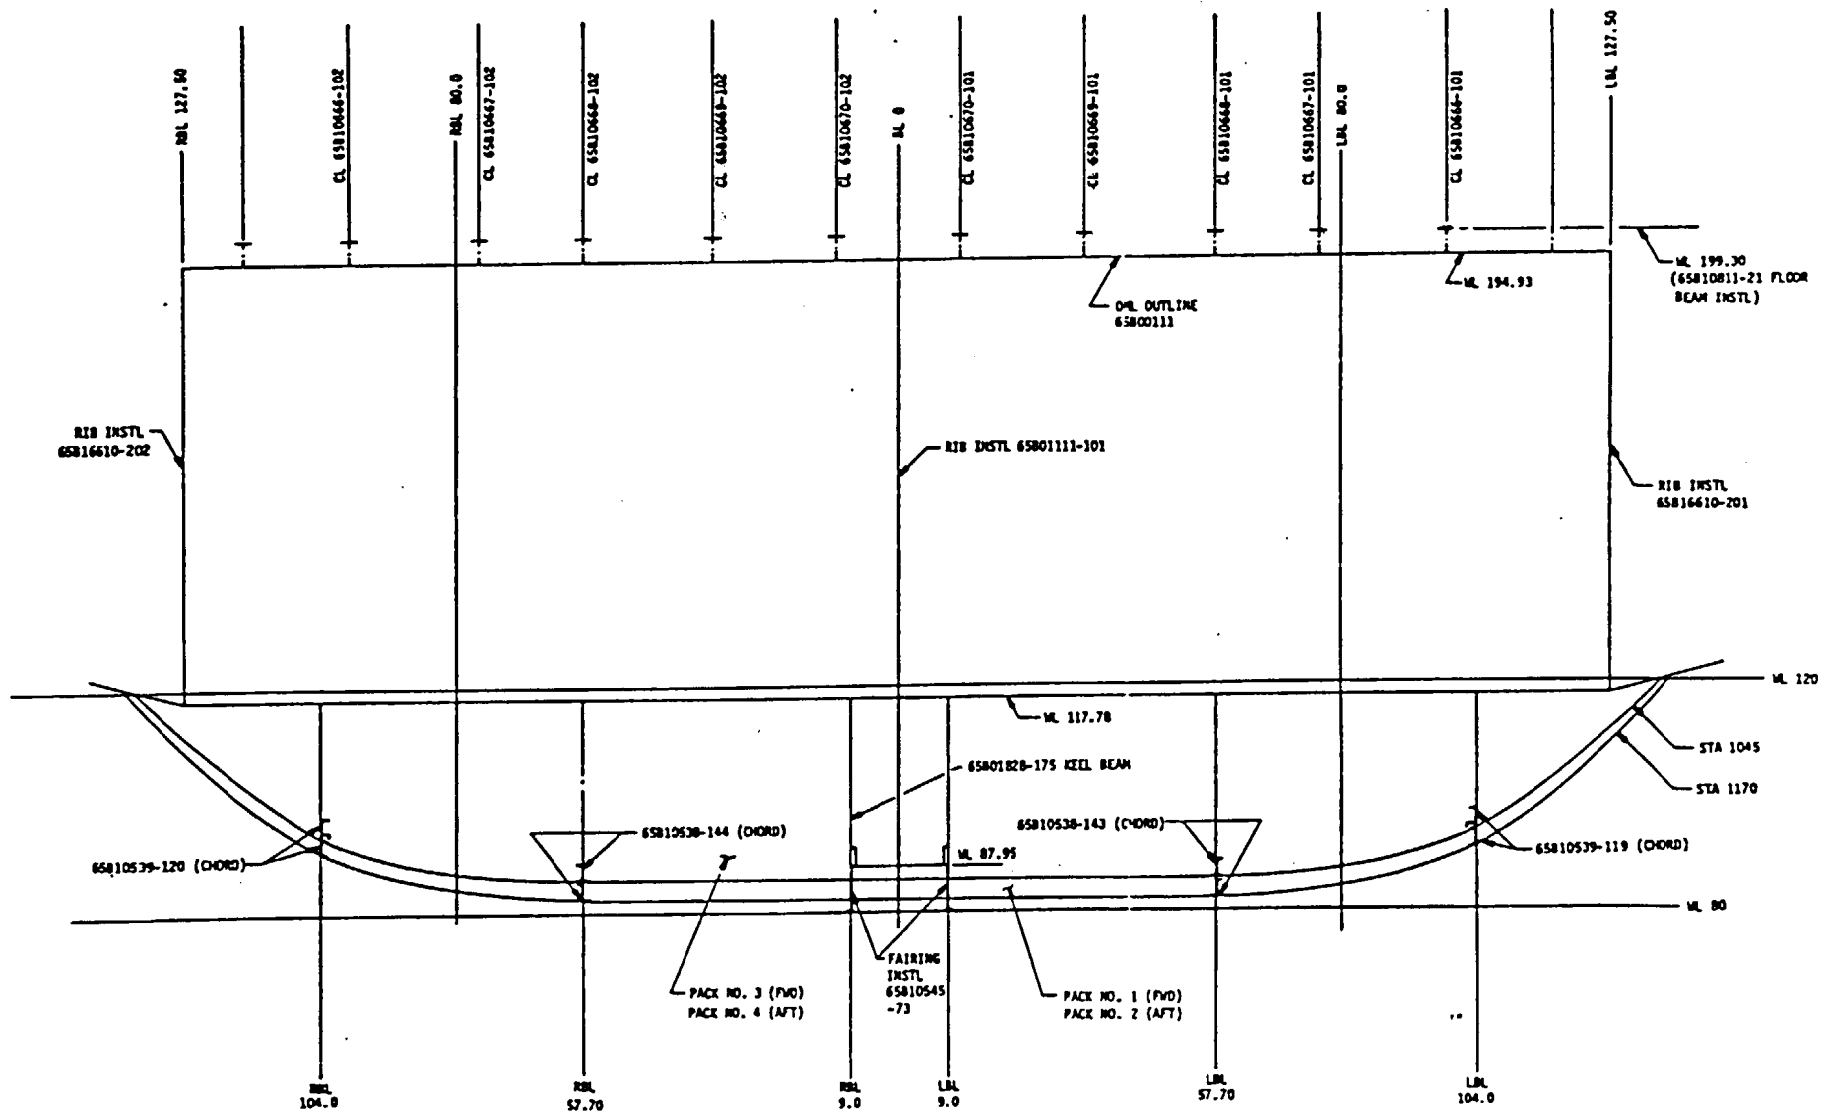
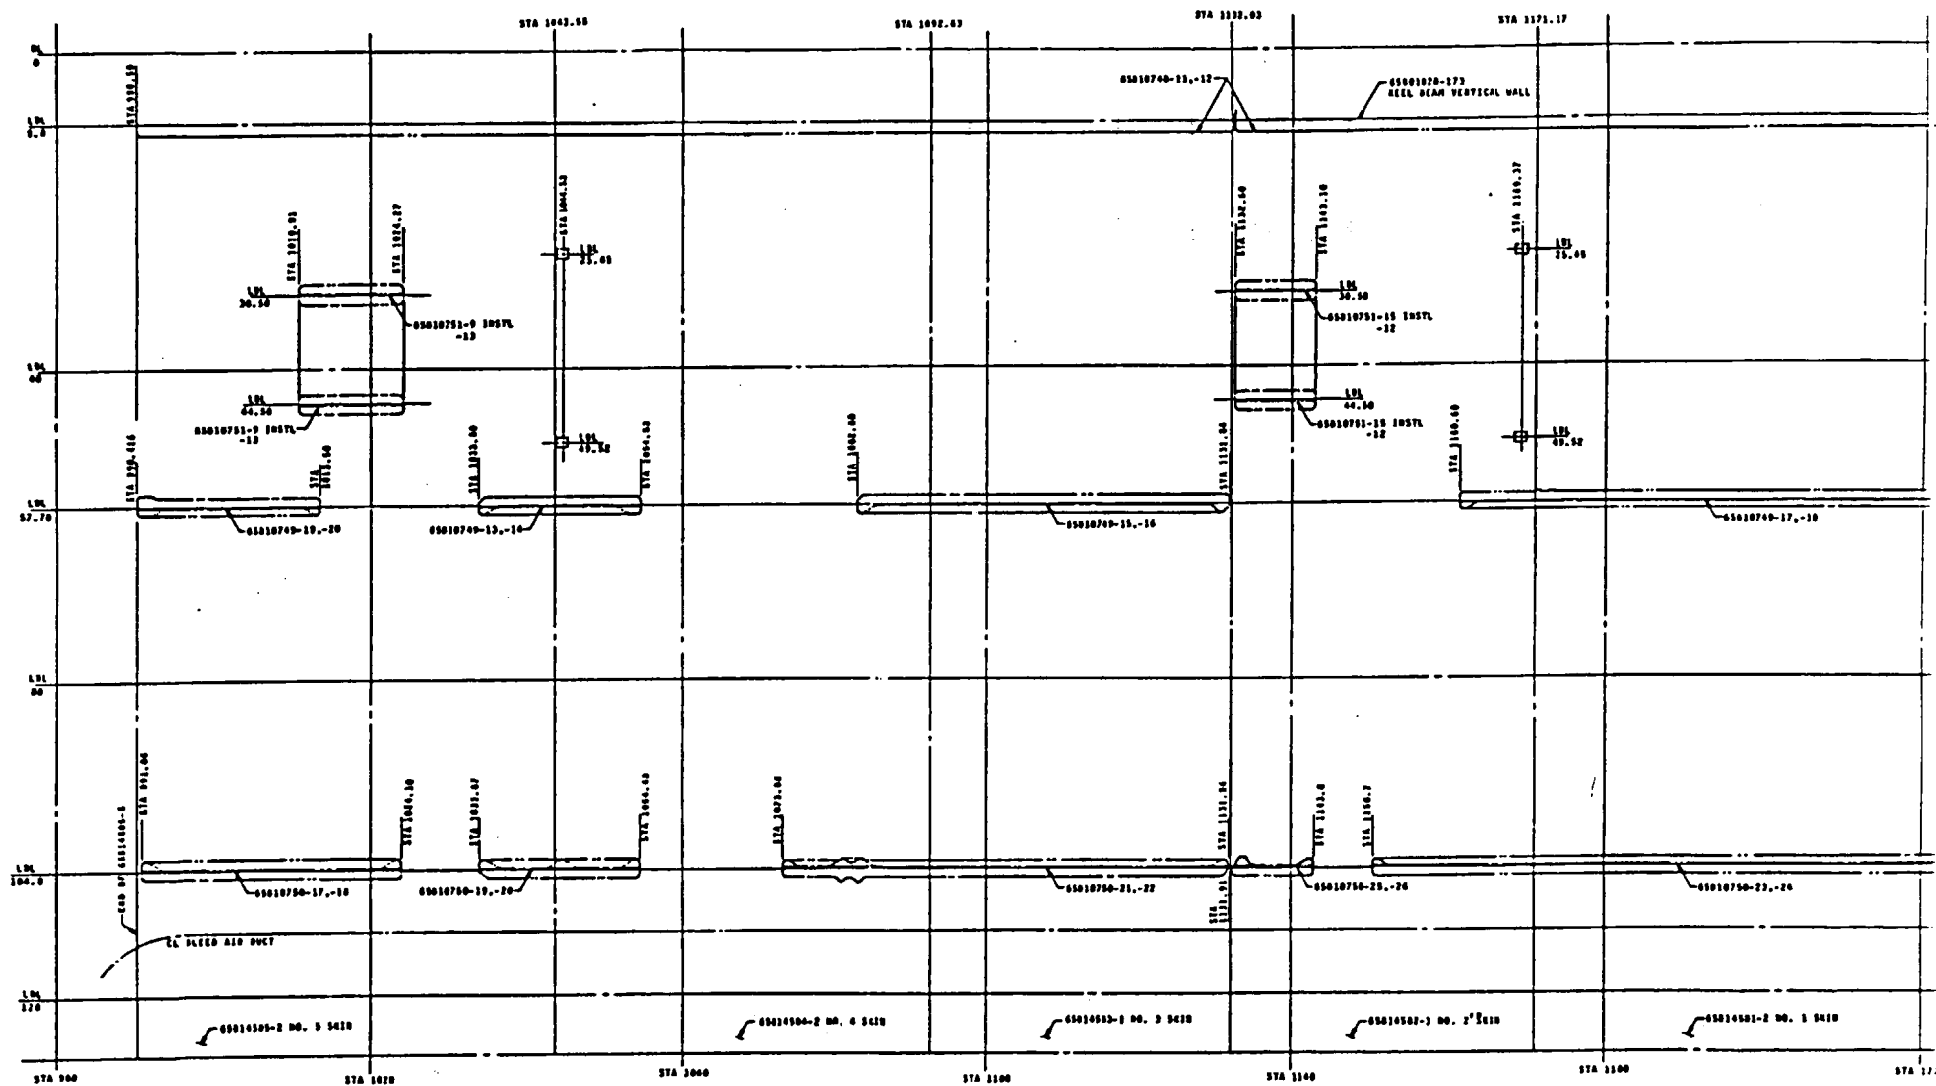
A structural diagram of the center wing tank was prepared. It shows the basic geometry of the wing center section and adjacent structure, and identifies front, mid, and rear spars, spanwise beams, tank end ribs, BL 0 rib, floor beams, keel beams, fairing beams, intercostals, upper panels, lower panels, and wing-body fairing. It is documented as Layout LO-1000, and is shown here as Figure 3.1.

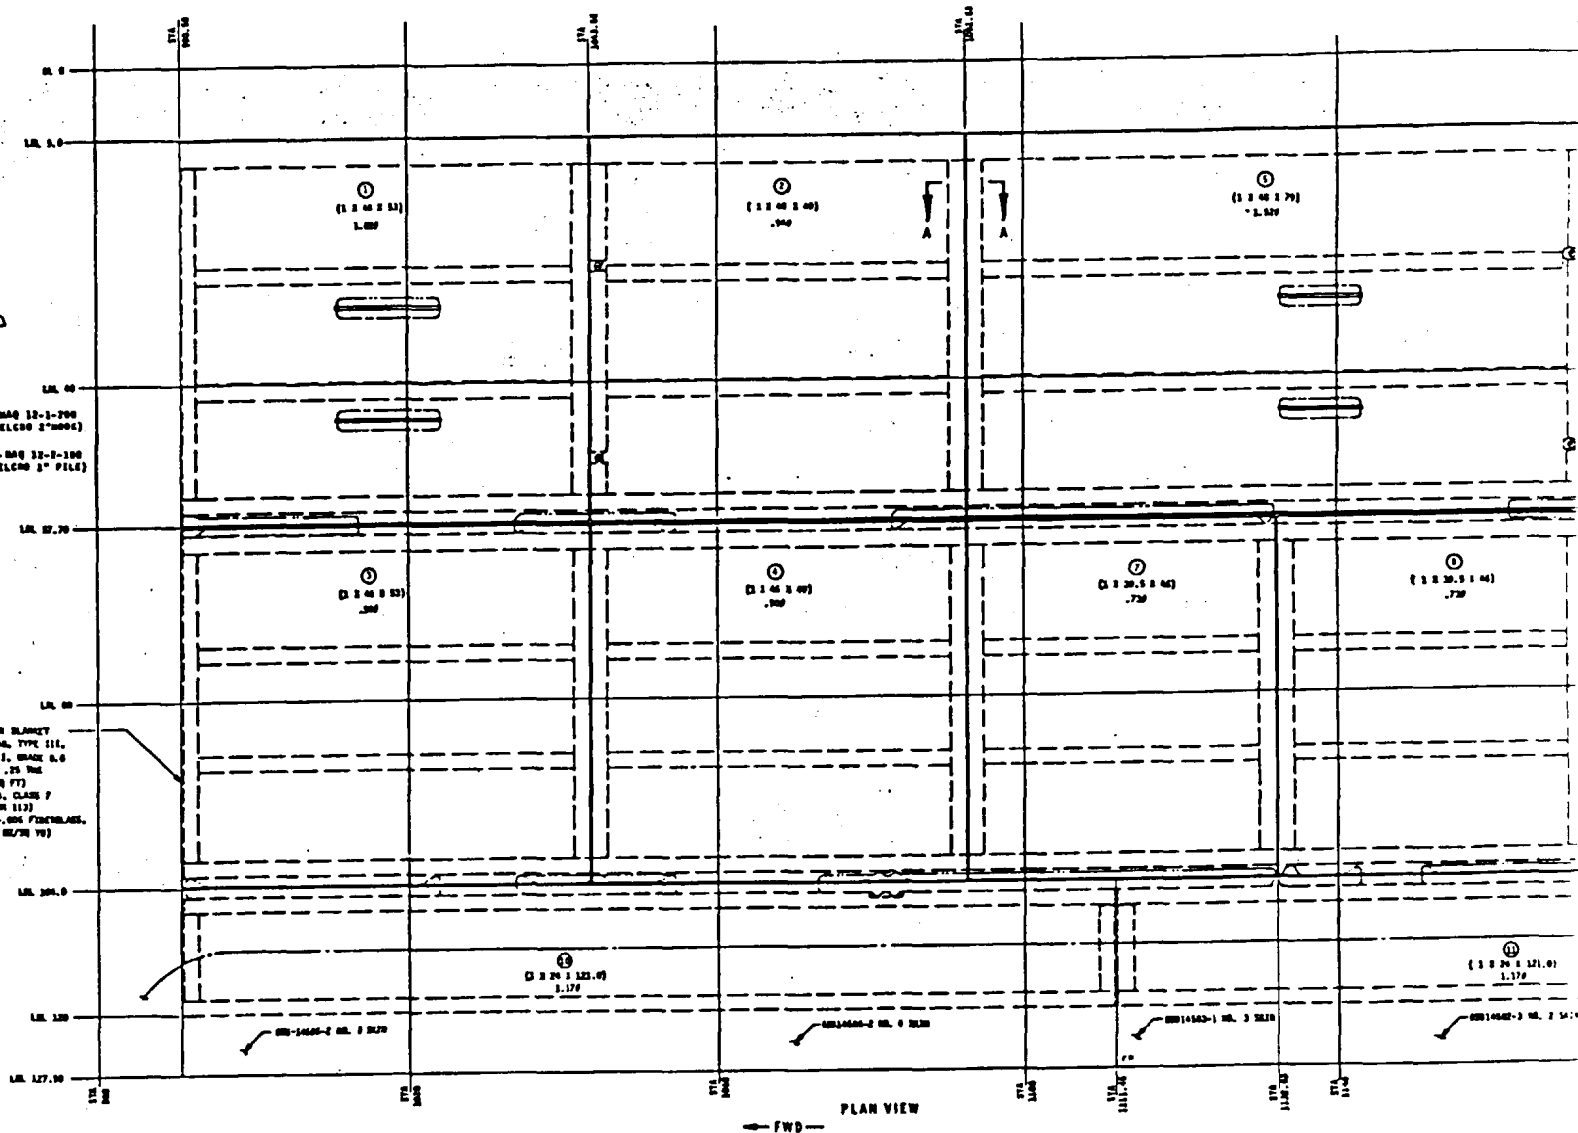
EO-1002
INSULATION INSTL-
LOWER PANELS.
WING CENTER SECTION
(LAYOUT)

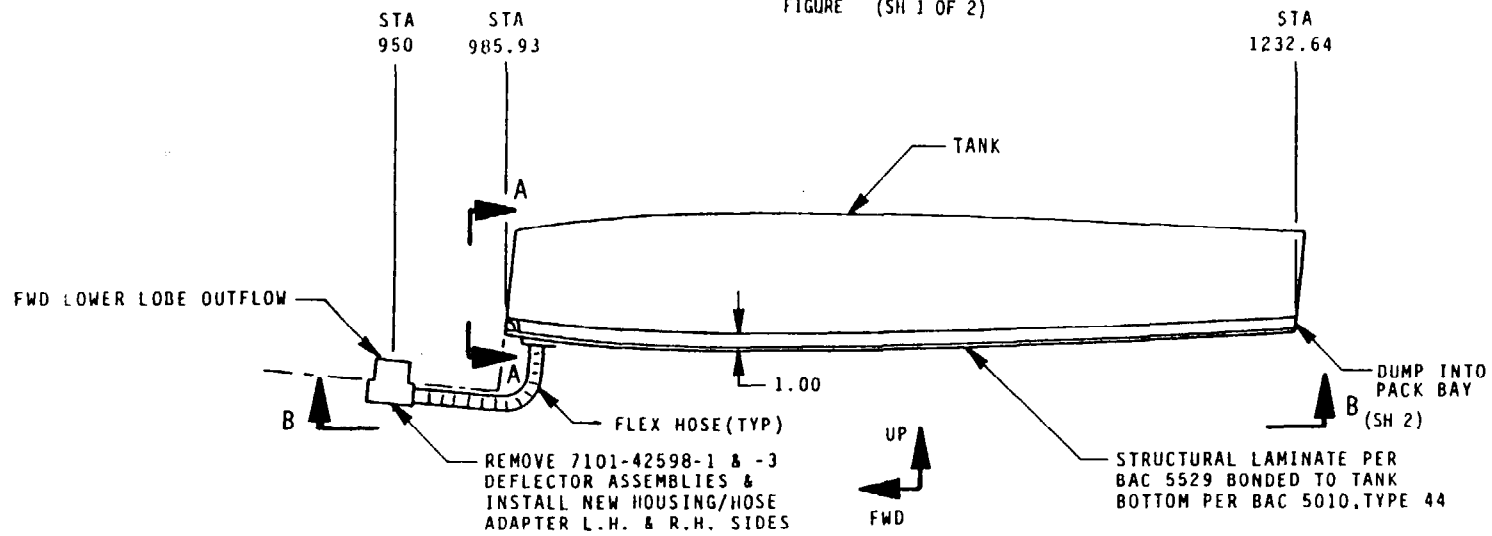
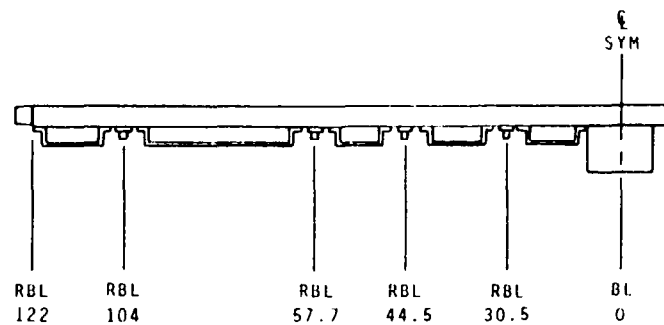
FIGURE 3.4 CENTER WING TANK SURFACE COOLING

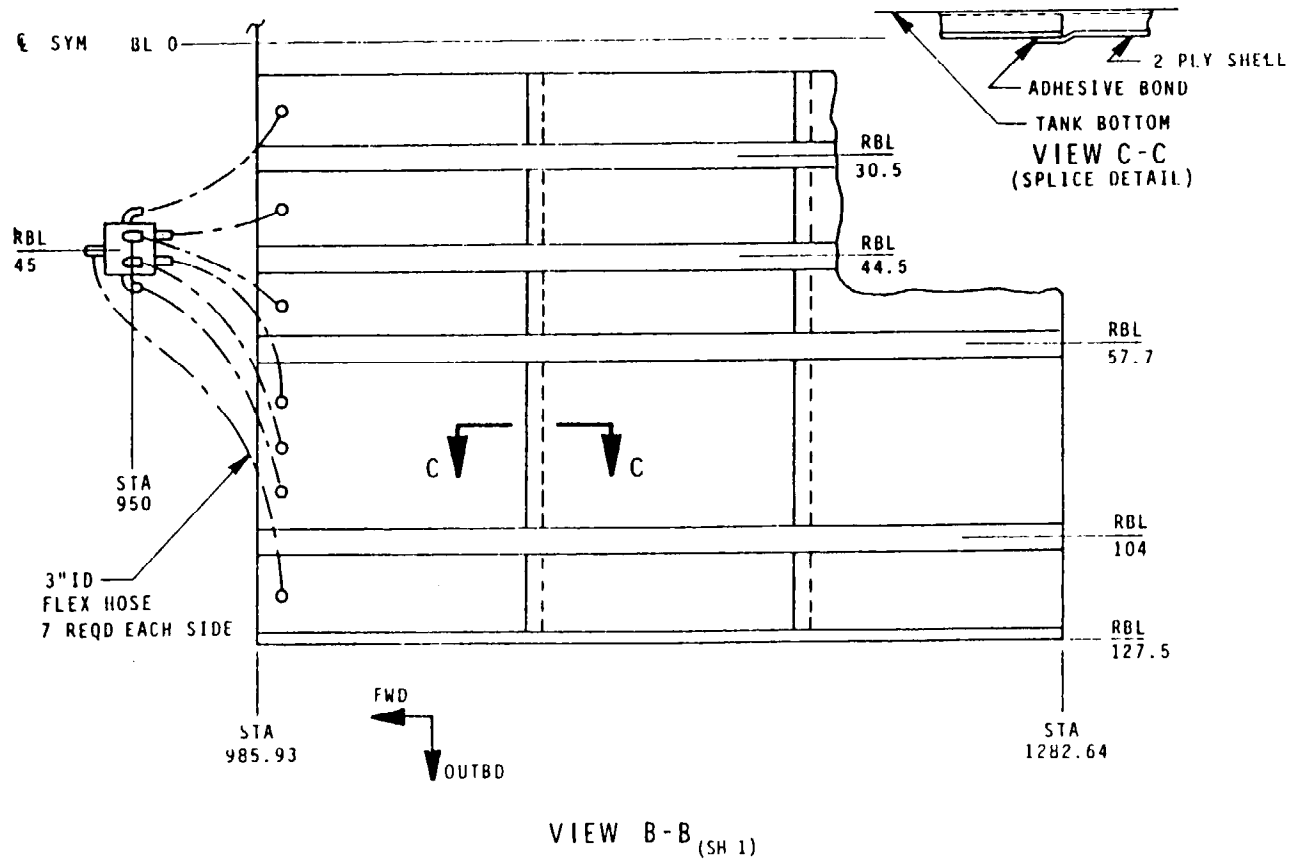
FIGURE 3.5 CENTER WING TANK SURFACE COOLING
